82C465MV Product Update

1 August 94

To: All OPTi 82C465MV Customers
From: Mark R. Williams, Technical Marketing Manager, (408) 486-8412
Subject: 82C465MV DMA/SMI Failure

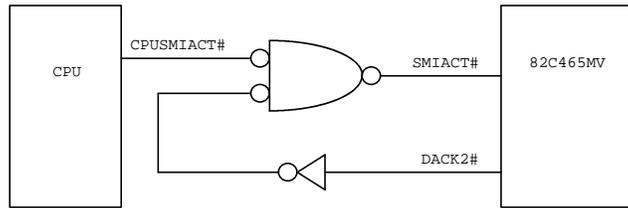
The circuit shown below handles only DMA channel 2, the most commonly used channel.

It is necessary to externally qualify SMI $\text{ACT}\#$ from the CPU with any DMA Acknowledge (DACK0-7#) signals in use from the 82C465MV chip using an OR gate. This solution prevents the 82C465MV logic from remapping the address by masking SMI $\text{ACT}\#$ during DMA transfers.

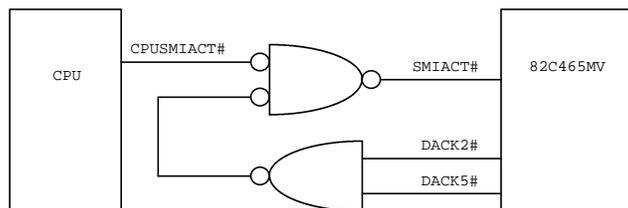
A circuit to handle two DMA channels would require the components shown below.
