82C465MVB Product Update

Revision 1.4 - April 1998

The product updates in this document refer to the OPTi 82C465MVB Single Chip Notebook Solution.

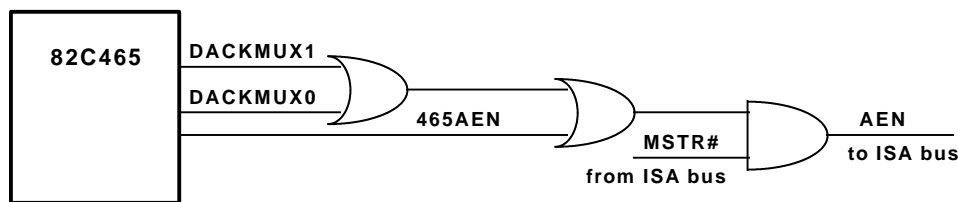
Figure 3. Correcting AEN for 16-bit DMA

The 82C465 series drops AEN prematurely during 16-bit DMA transfers. The AEN signal should remain high at least for the duration of the ISA command lines (IORD#/IOWR#, MRD#/MWR#) during DMA. But AEN will drop low mid-way through the command, possibly allowing an I/O device to decode the transfer as a standard input/output command.

The 82C465 chip itself can decode this cycle and hang the system under certain circumstances. Generally this failure mode is evident only when writeback CPU operation is enabled.

- If there is no possibility of 16-bit DMA occurring, no workaround is required.
- If no local ISA devices will misinterpret the DMA transfer as an I/O access, it is sufficient to simply set register 43h[2:0]=000 to enable synchronous ATCLK operation. The internal logic of the 82C465 chips will not misinterpret the DMA access as an I/O access when in synchronous mode.
- If full ISA support is expected, the fix shown in the figure below must be implemented using two 7432 gates and a 7408 gate. Note that if ISA masters are not supported, the 7408 gate is not required.
